Impacts of Low-Head Dam Construction and Removal with Little Channel Sediment Storage: Case Study from the Maury River, Virginia

Chantal Iosso and David Harbor

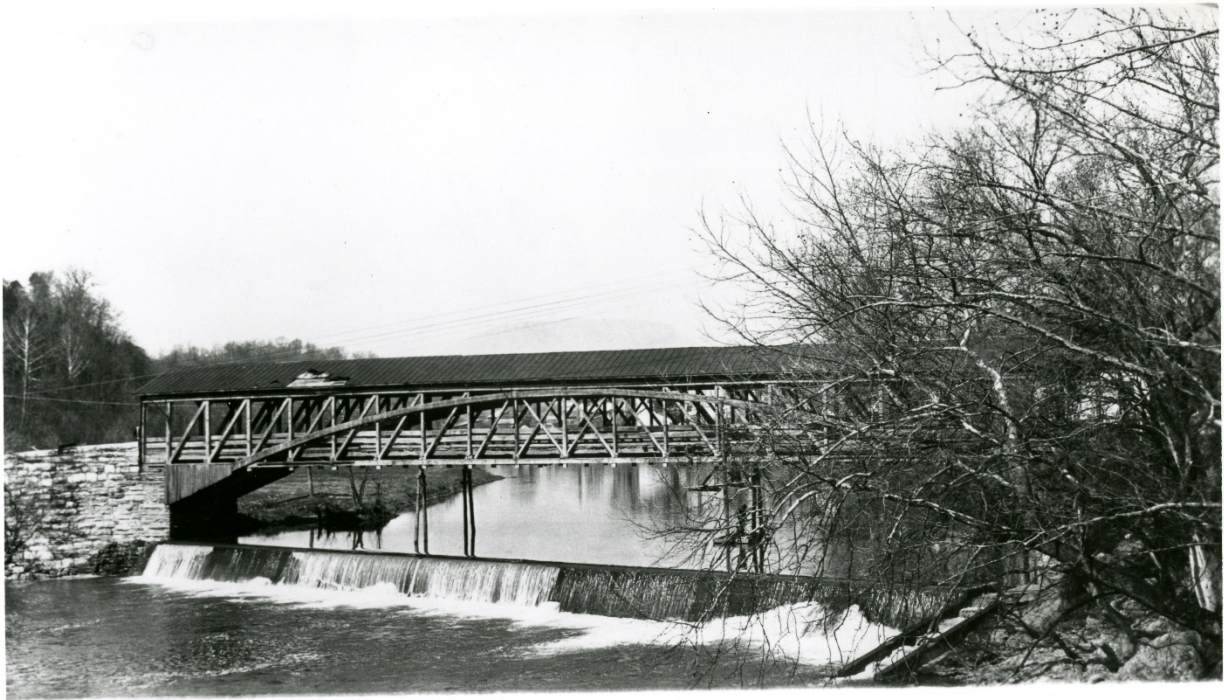
Figure 1. Historic image of the Jordan's Point Dam.

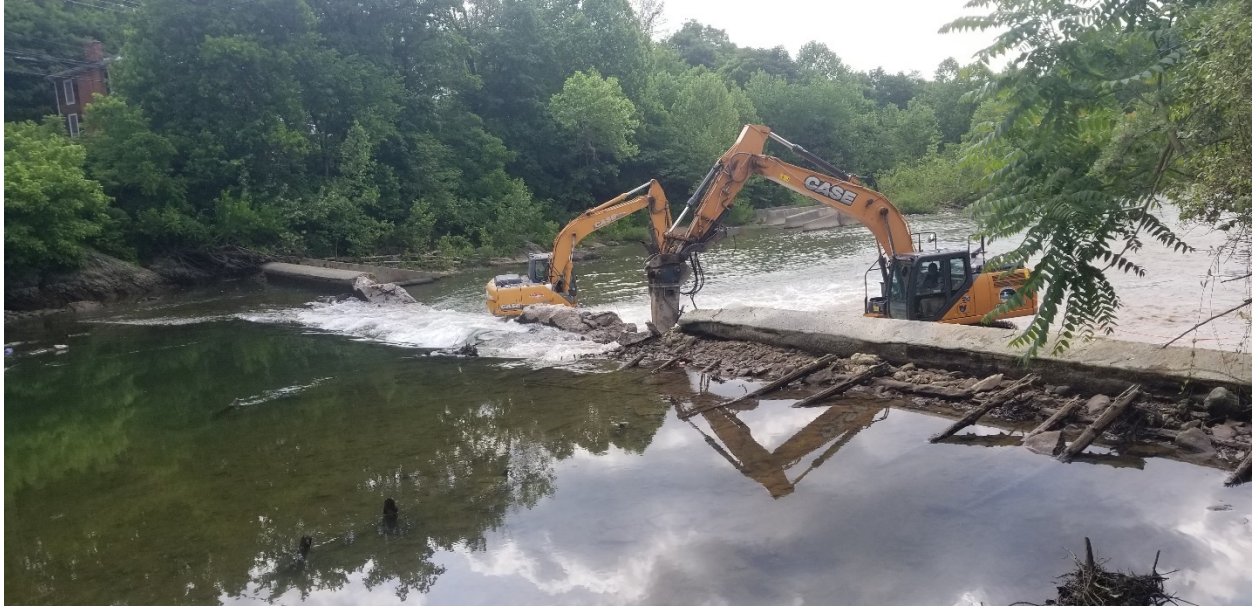
Figure 2. Image of the Jordan's Point Dam being removed in May 2019. Timbers of the older, un-breached crib dam in front of which the concrete dam was built are visible.

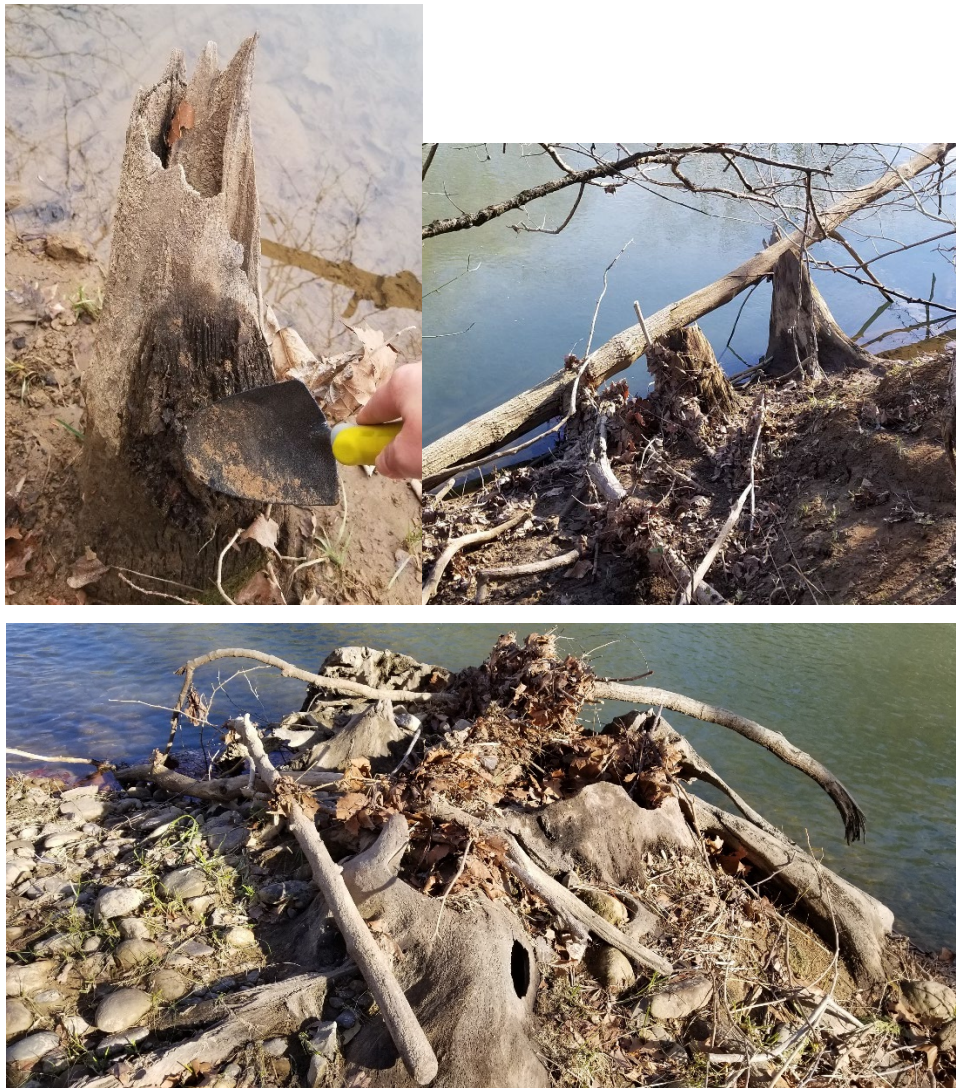
Figure 5. Stumps from trees that grew below the impoundment water level, with roots at current water level. Outer rings of three of these stumps were sampled for radiocarbon dating. The bottom stump is >1-meter-wide and partially filled with cobbles in the interior. This suggests a long period of low water level stability for tree growth and cobble transport after the tree died.

To verify whether the material sampled represented historic human-related sedimentation, we conducted radiocarbon dating on multiple dead stumps which grew just above the current water level (revealed by the water level drop following dam removal) (figure 5). We sampled the outer rings of three such dead stumps to determine if the time of their death corresponds with dam construction, which would provide an estimate for prehistoric floodplain height and quantity of legacy sediment accretion. Wood samples were dried at 80 degrees Celsius for 72 hours and cleaned to remove soil, rootlets, insects, or other potential sources of modern carbon.

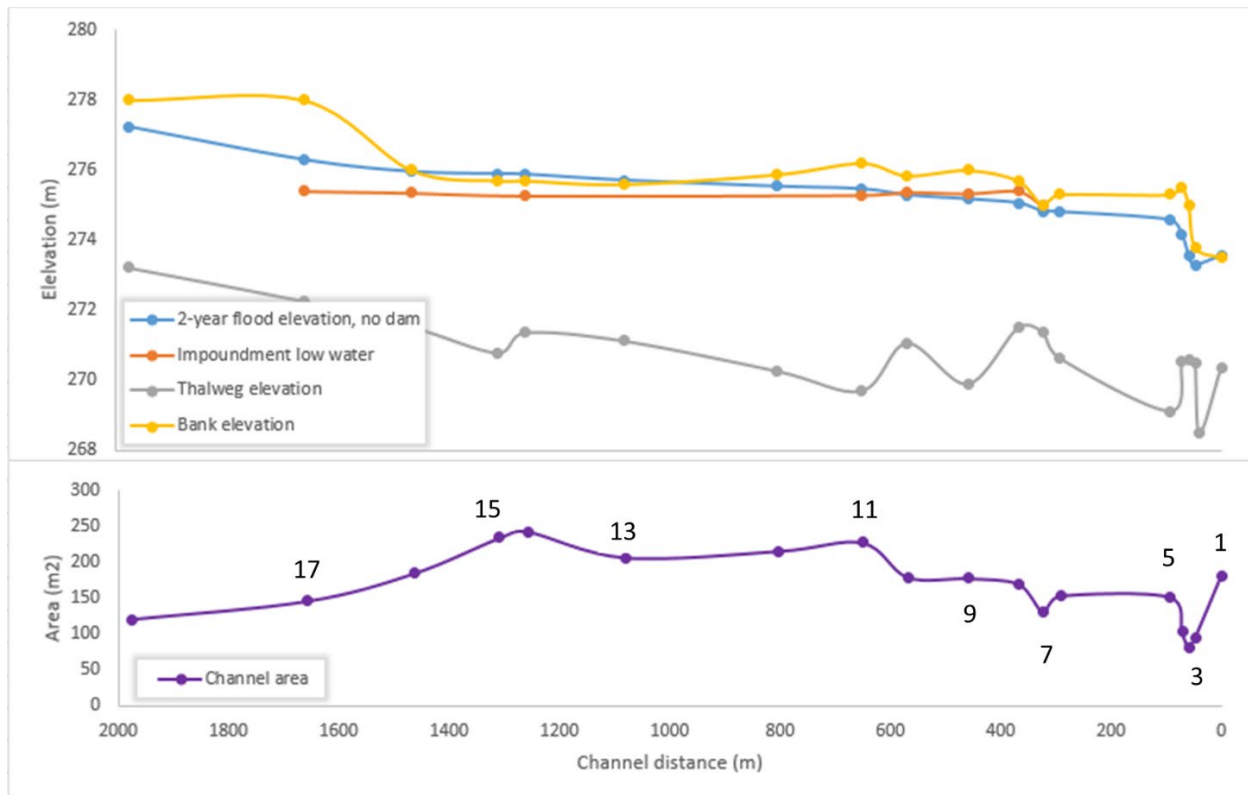
Figure 6. Longitudinal profile of the thalweg, left bank, impoundment low-water line, post-impoundment modeled two-year flood elevation, and two-year-flood cross sectional channel area.

In contrast, bank heights throughout the impounded reach are fairly consistent at about half a meter above the low-water level of the impoundment while the dam was in place. Bank height drops about two meters past the crest of the dam. Channel area is highest between cross sections 11 and 15, narrowing in the upstream reach and in the vicinity of the dam (figure 6).

Sediment transport capacity is largest near cross section 3 (the remnants of the dam and sediment ramp) and 17 (the top of the impoundment), where slope is steepest and the channel is the most narrow (figure 6). Sediment transport of all but the largest clasts can occur here in almost any flood condition. Smaller sediment transport peaks occur near cross sections 7 and 13; 50- and 100- year floods can move most material here. Without the dam in place, all floods can move median material here as well. In contrast, a 50- or 100-year flood was required to transport

As a low-head dam, it is unlikely that major changes to channel morphology beyond the channel bed occurred while the dam was in place. Bed structure such as the sediment ramp and plunge pool beneath the dam (cross sections 3-4 and 2, respectively, figure 6) likely were created by the dam. Similarly, the higher bed elevations at cross section 8 may be a sediment ramp from the remnants of the crib dam. Pool-riffle sequences, such as the extended pool between cross sections 11 and 13, exposed by dam removal could have been formed during the 200-year presence of the dam, due to the ability of most cobbles to move in 50-year flood (figure 9). However, due to the lack of historical imagery of the Maury River from before the mid-20th century, more than 100 years after the dam was first constructed, the pre-dam channel geometry is largely unknown.

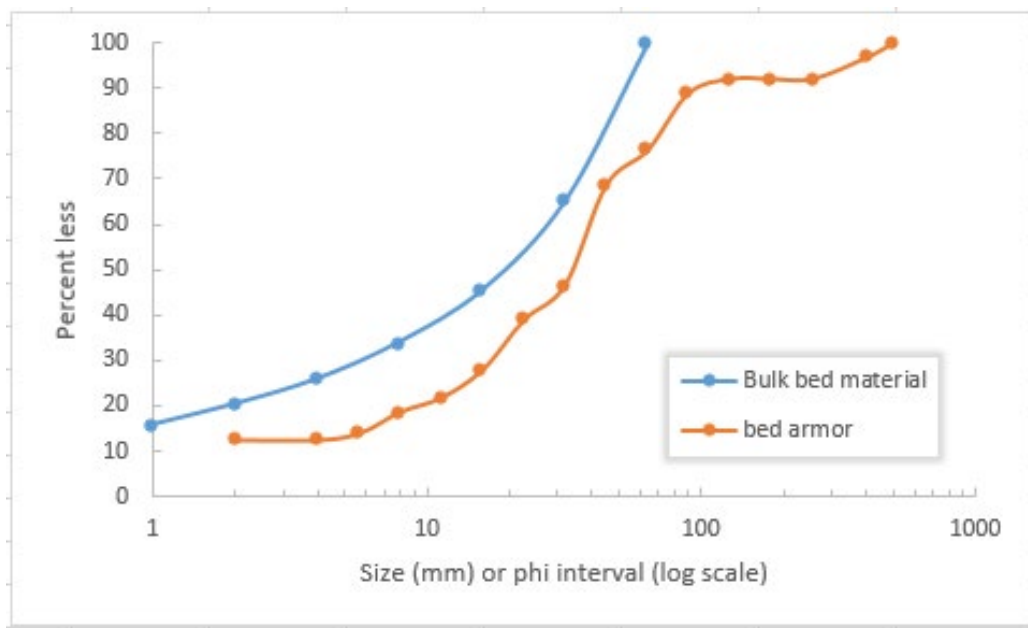
Figure 7. Example sediment size distributions of bar armor and bulk bed samples from cross sections 14 and 15.

Median (D_{50}) bed armor particles ranged from 23 to 50 mm, and D_{90} bed armor particles ranged from 74 to 150 mm. For the bulk bed material, D_{50} particles ranged from 14 to 23 mm, and D_{90} particles ranged from 53 to 94 mm. There was no clear relationship between particle size and proximity to the dam, although the coarsest material was within the sediment ramp upstream of the dam and at the top of the impoundment (table 2). The bulk sediment is distributed regularly, but the bed armor in all areas sampled exhibits a coarse tail (figure 7).

Distribution of channel sediment and modeling provides evidence for changes in sediment transport while the dam was in place. Like previous studies documenting a coarsening of the bed behind the dam (Skalak, Pizzuto, & Hart 2009), we observed a coarse tail on the distribution of bed armor (figure 7). This coarsening is most evident at the dam and at the top of the impoundment, where finer material continued to be transported while coarse material was deposited (table 2). Pearson and Pizzuto (2015) document transport of gravels and fine cobbles over low-head dams, which may have occurred on the Maury River to produce the observed distribution, leaving disproportionately large material behind. Moreover, model results support this possibility as median particles could move through the impounded reach in as little as a five-year flood, and a 50-year flood or greater could move all material in the stream. One of the stumps that died in 1700s was internally hollowed out with large cobbles inside, which indicates that these larger than median-sized cobbles moved after the tree died and while the dam was in place (figure 5). Combined, this evidence clearly indicates that particles much smaller than the median particle (sand and gravels) moved over the dam easily in floods, and coarser material built the bar and pool structure observed upstream of the dam.

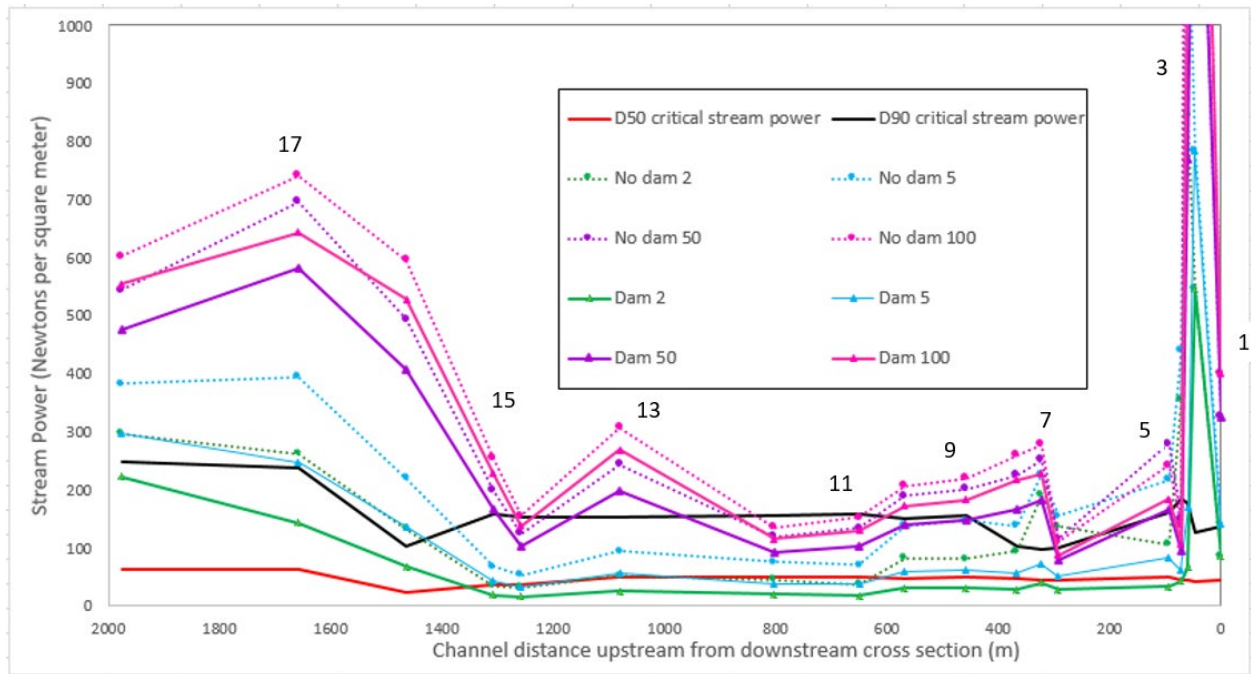
Figure 8. HEC-RAS modeled stream power with and without the dam in place in 2-, 5-, 50-, and 100-year floods from 75 meters below the dam to about 2 kilometers upstream, compared to the critical stream power required to move D_{50} and D_{90} bed armor material.

sediment anywhere but above the top of the impoundment and at the dam while the dam was in place. Model results predict that dam removal will result the biggest increases to sediment transport capacity within 500 meters upstream of the dam; D_{90} particles can be moved in even a 2-year flood without the dam, which would have required a 50-year flood while the dam was in place (figure 8).

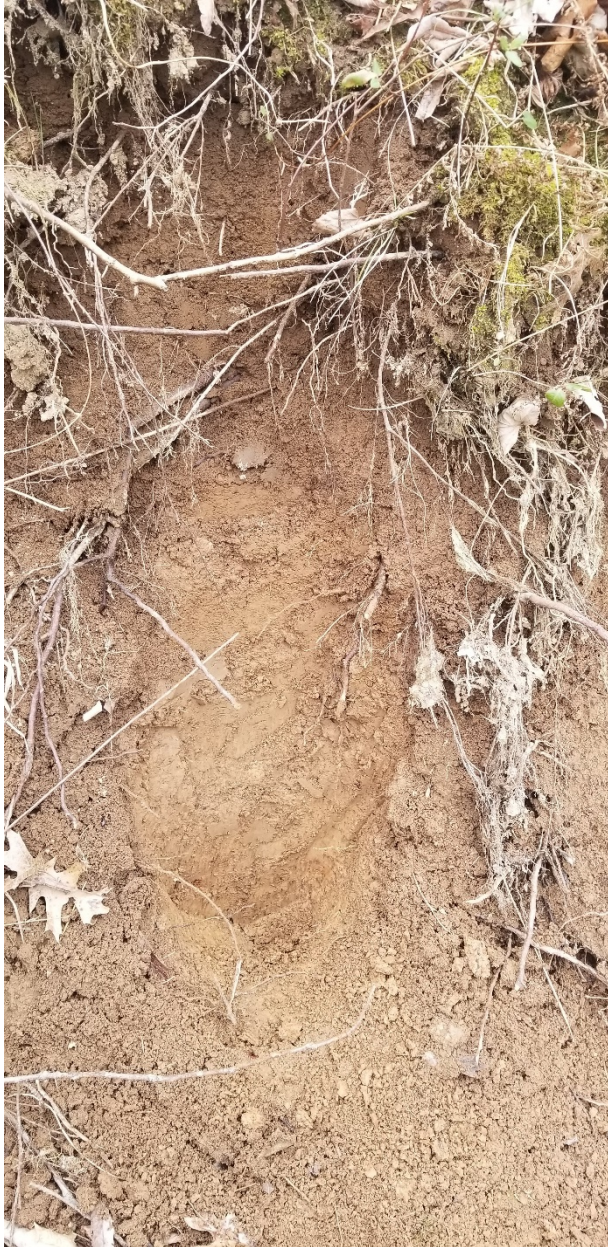
Figure 9. An exposure of uniform fine-grained bank material.

Bank material, sampled at several locations, was mostly consistent in color and texture both laterally and vertically. We observed minimal layering or soil development and found no evidence of a paleosol (figure 9). Most of the bank material was massive sandy loam with about 70% sand content, although clay content increased below the impoundment low-water level (table 3). We calculated the shear strength of the predominant bank material if left bare, planted with grasses, stabilized with trees, or stabilized with dense trees in the area with the most exposed steep, muddy bank material (between cross sections 7 and 12). Shear stress of flow exceeds shear strength of bare or grassy banks in all floods in this region, and of sparse tree-

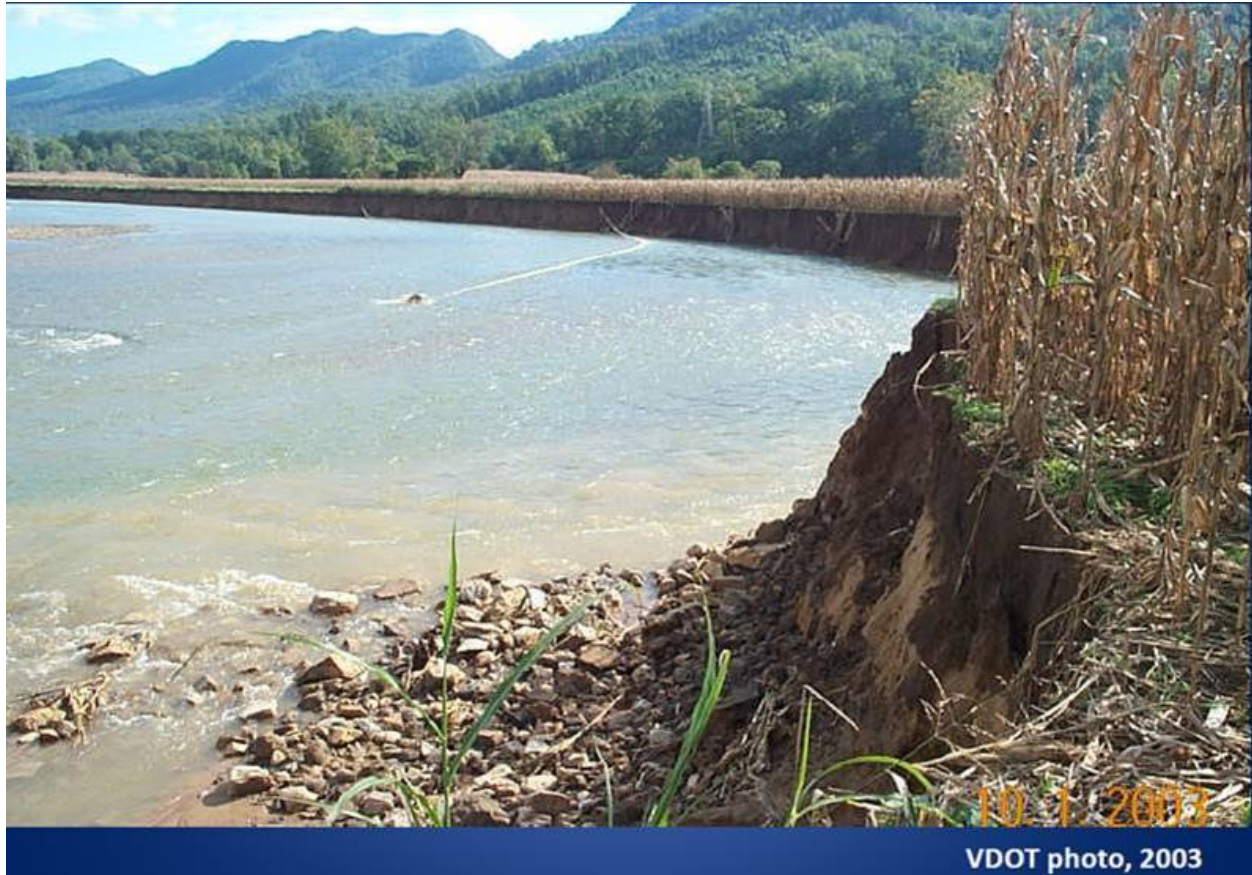
Figure 11. Severe bank erosion in 2003 on the Maury River (downstream of Jordan's Point) due to bar migration and growth following a dam removal in 1974 (photo credit: Virginia Department of Transportation).

The potential harm such bedload transport can do is illustrated by a case further downstream. Following removal of the Balcony Falls dam on the James River near the Maury River confluence in 1974, dramatic growth of cobble bars at the head of the dam was matched by significant erosion of legacy sediments from the opposite bank between 2003 and 2014 (figure 11), releasing approximately 702 tons of sediment per year into rivers draining in the Chesapeake Bay (“Maury River Stream Restoration” 2016). The Maury River may evolve similarly in the area of the Jordan’s Point Dam now that cobbles can easily be mobilized in the channelized reach immediately upstream of the dam.

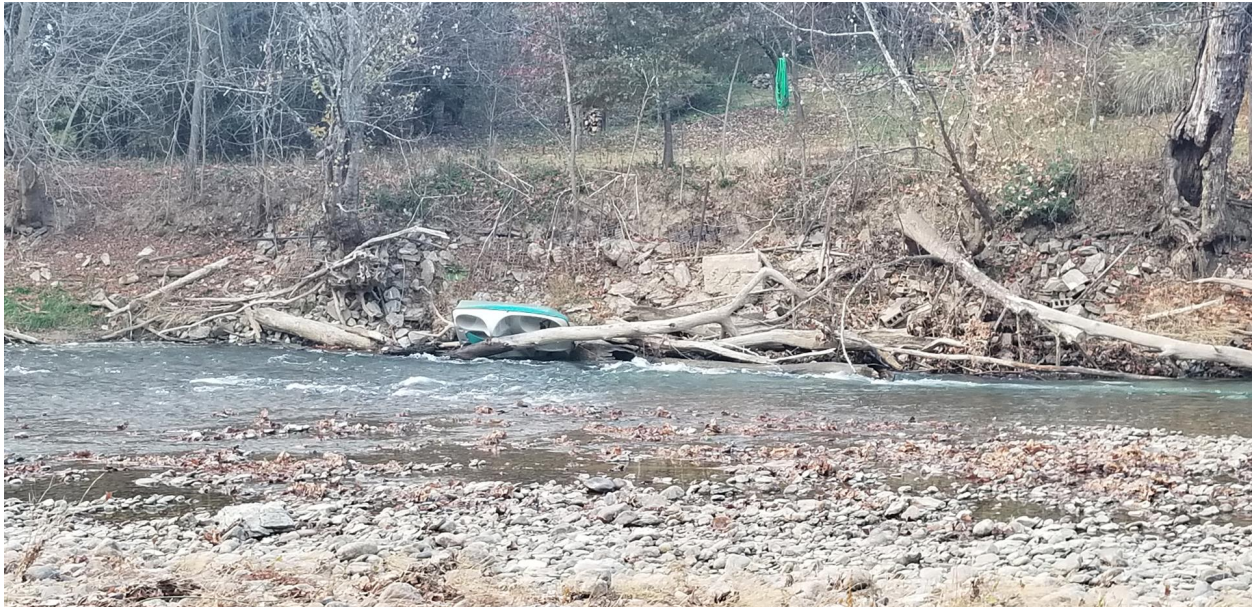
Figure 12. Channel migration into the left bank, resulting in bank erosion at cross section 7 (photo taken December 2019). Most of this discarded debris predates the removal of the dam where the impounded reach suffered erosion in high flows along the outside of a bend. Nonetheless, bank erosion is ongoing following dam removal.

erosion is already occurring especially near cross section 7 (figure 12) where the modeled shear stress peaks locally (figure 10). High banks in this reach will likely require further stabilization. Even dense tree stabilization may be insufficient to resist shear stress applied by moving cobbles in flood events as bars build.
